LANGAN ENGINEERING ASSOCIATES INC CLIFTON NJ  
NATIONAL DAM SAFETY PROGRAM. UNTERMAYER DAM (NJ00253), PASSAIC --ETC(U)  
JUL 78 D J LEARY

REPORT DOCUMENTATION PAGE		READ INSTRUCTIONS BEFORE COMPLETING FORM
1. REPORT NUMBER NJ00253	2. GOVT ACCESSION NO.	3. RECIPIENT'S CATALOG NUMBER
4. TITLE (and Subtitle) Phase I Inspection Report National Dam Safety Program Untermeyer Lake Dam Morris County, N.J.	5. TYPE OF REPORT & PERIOD COVERED 96 FINAL / Rept. 1

PHASE 1 REPORT  
NATIONAL DAM SAFETY PROGRAM

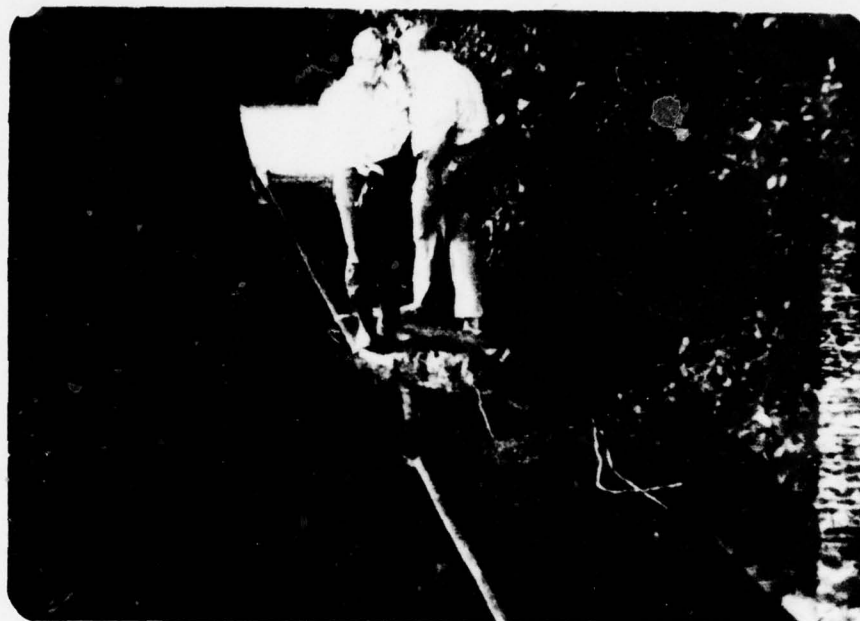
30 June 78 (Evening)

NJDEP personnel atop masonry spillway, beside partially deepened notch (18-inches) in the spillway wall of UNTERMEYER Dam. (Notch later extended to depth of 4-feet from top of spillway.)

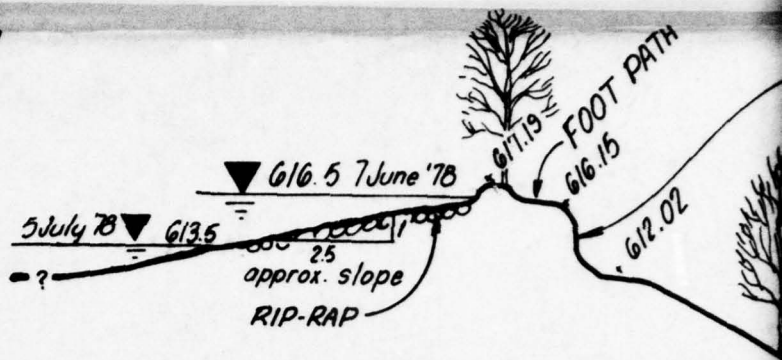
EMBANKMENT - CROSS  
SECTION C

LEAK NOTED  
29 June 1978

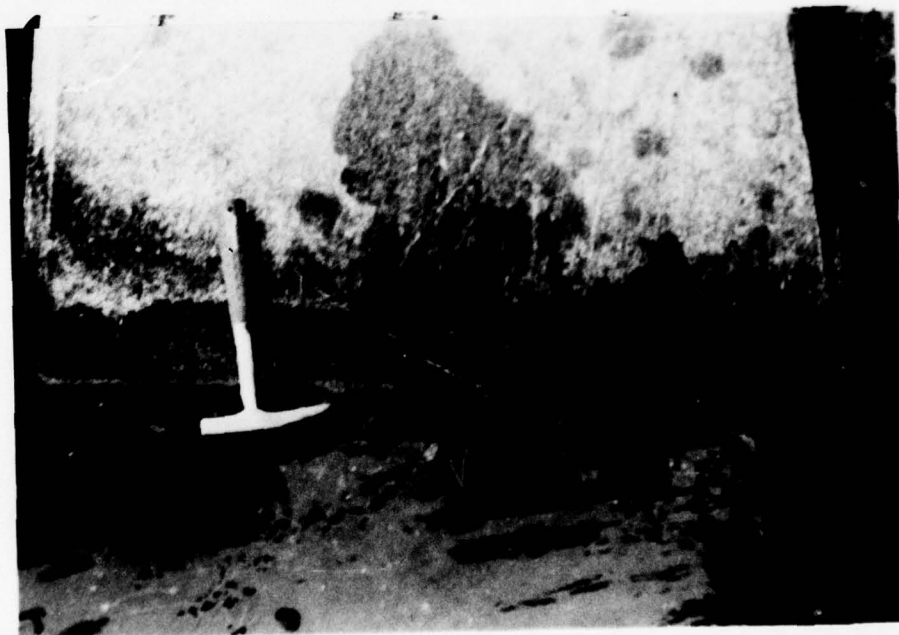
Crack in concrete spillway      8 June 1978  
crest

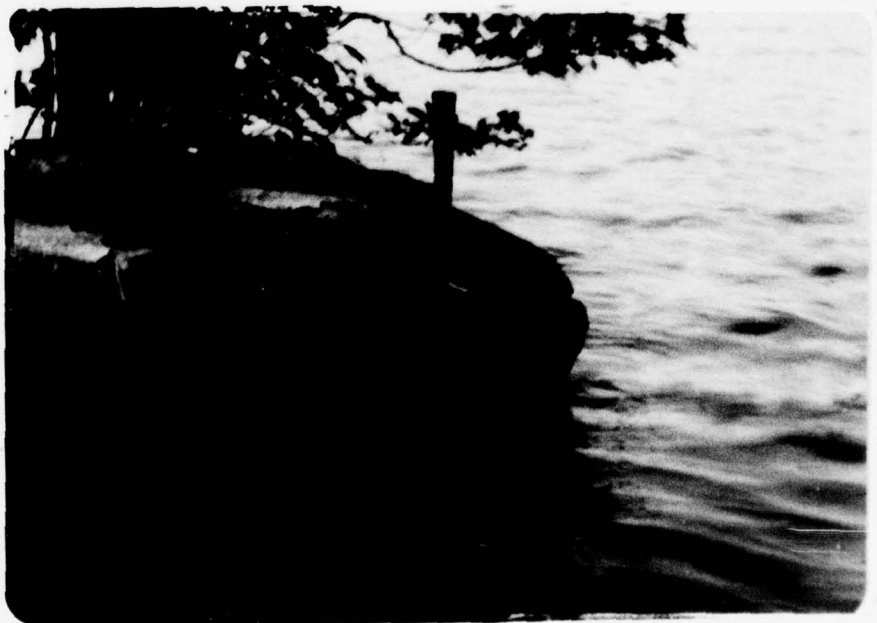
The spillway masonry is in good condition. The right side wall of the spillway needs repair. Some stones have fallen down from the upper part, and leaks, approximately 1 gpm exist in this area. The left abutment is on rock and in better condition with minor leakage, approximately 1/16 gpm.

Failure of masonry at end of right  
spillway abutment wall

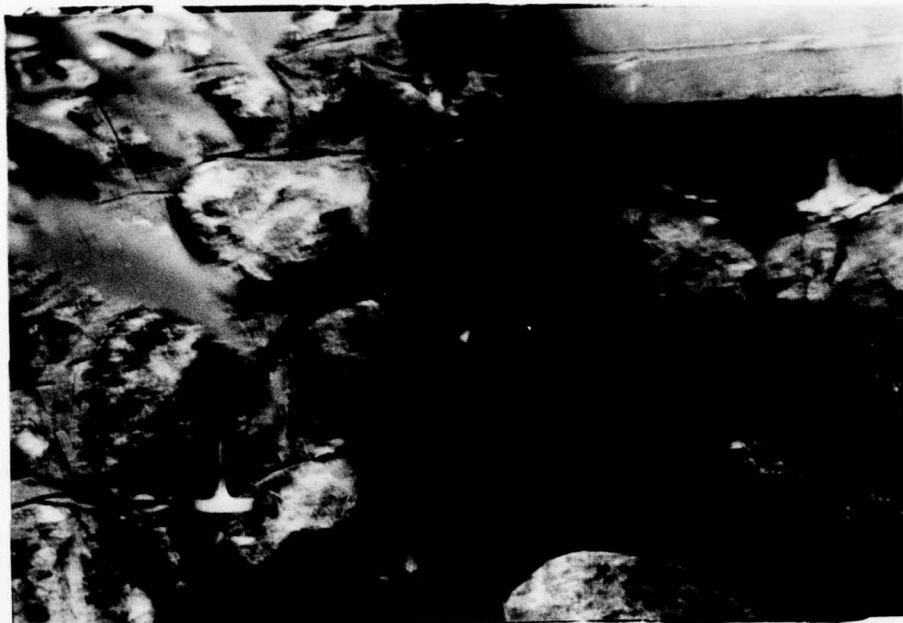
Rock falling from masonry at  
downstream corner of spillway  
and right abutment.

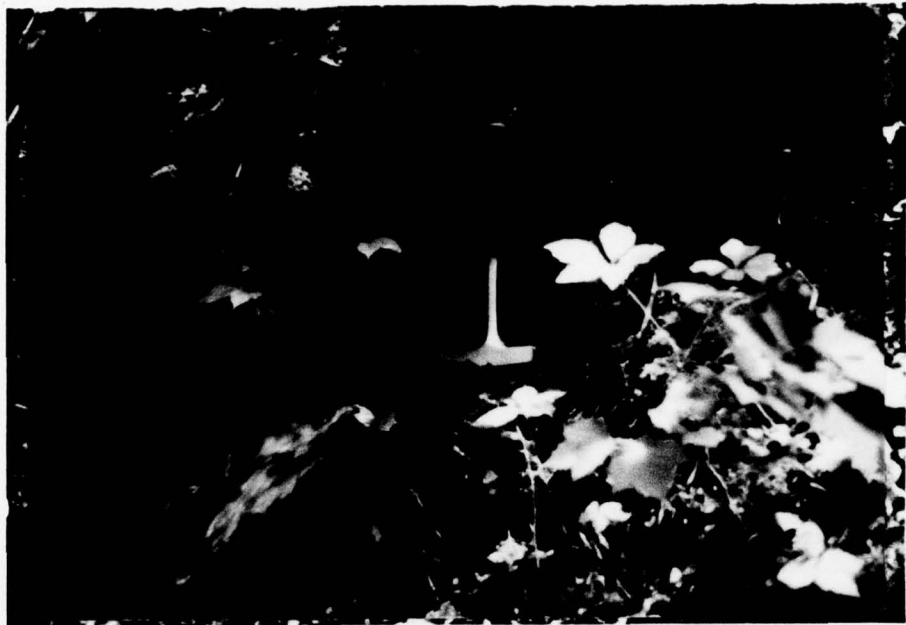
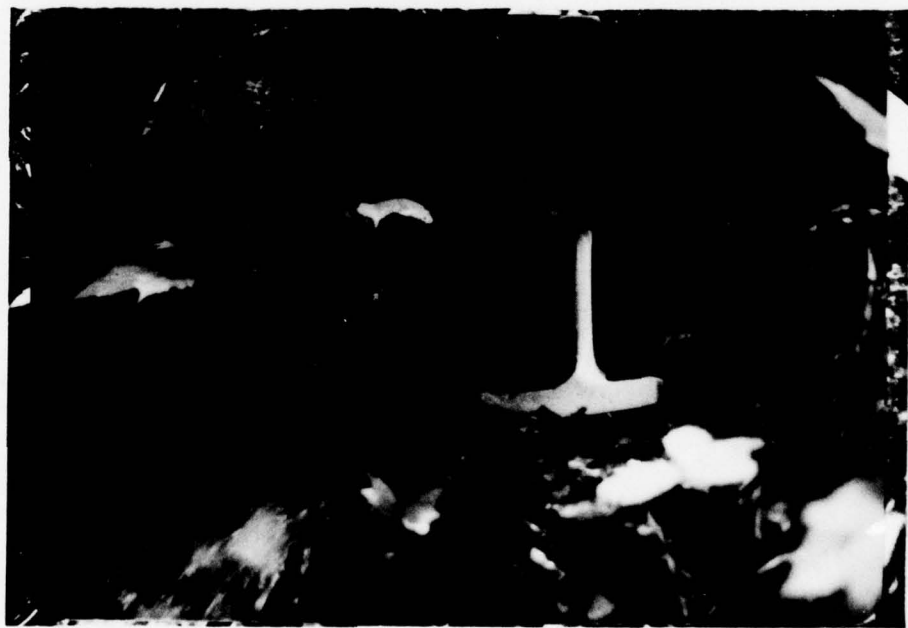
On 29 June a leak was observed on the downstream face of the earth embankment. Leakage was occurring at about 15 gpm from a single source located 4 ft below the crest and 110 ft from the spillway. The water was clear. In addition, the downstream face of the embankment in the area of the leak was wet and spongy. Mr. W. Rogers of the N.J. D.E.P. Division of Water Resources, Bureau of Flood Plain Management was informed of the conditions and their critical nature with respect to the stability of the embankment. Subsequent inspection and action were taken by the D.E.P., Corps of Engineers, and the Owner. Sketches showing the observed conditions are included in Appendix 3. Lowering of the lake was started about 6 p.m. on 30 June and the leak in the embankment had stopped when the lake water level had lowered about six inches.

Leak at downstream face  
of embankment.
